AmeriSpec Home Inspection Service
250 Dundas Street South
Cambridge, ON N1R 5A5

Home Inspection Report

Client:	Greg Smith	Inspection No:	270413131
Address:	166 Main Road Acton, ON	Inspection Date:	13/08/2007
Inspector:	Denise Larocque, RHI

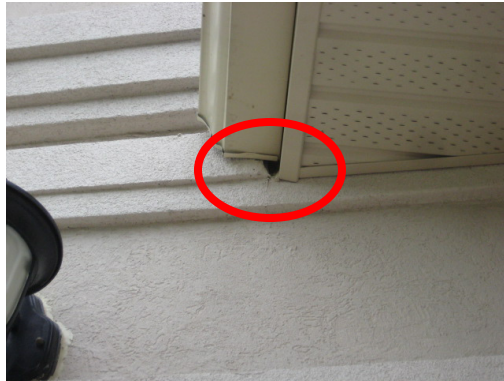
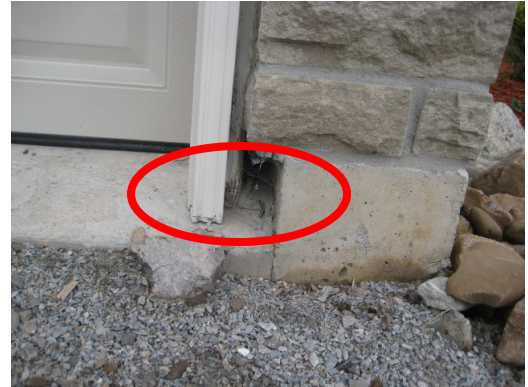
Patching of mortar noted at the rear.

Damaged EIFS noted at the rear.

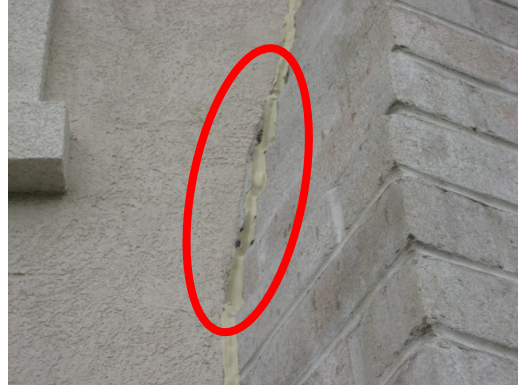
Openings/breaches were noted around the exterior of the home. We recommend sealing any openings to prevent potential moisture damage to exterior/interior walls and pest incursion.

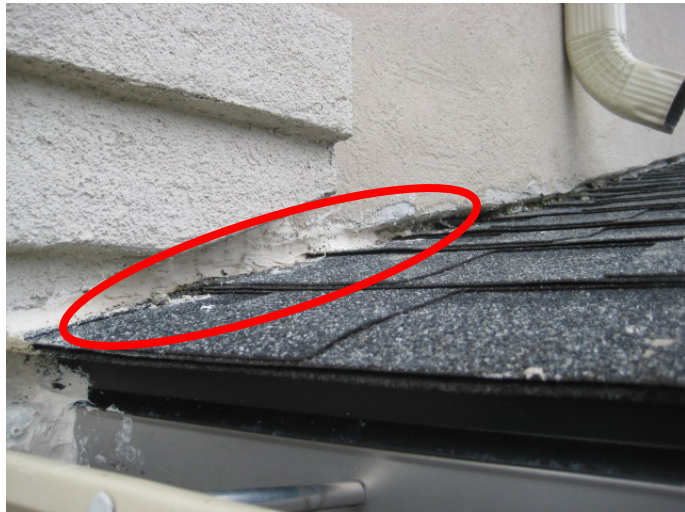
Some amateurish installations noted. All flashings should be reviewed by a licenced contractor.

Possible sensitive areas with respect to water infiltration are commonly found around plumbing vents, roof vents, chimneys, valleys and roof/wall interfaces. These are vulnerable areas that are present around most homes. In order to reduce the potential for water infiltration into the home around the above-noted areas, we recommend ensuring that the noted area(s) area properly sealed by a qualified roofing contractor as part of routine maintenance.

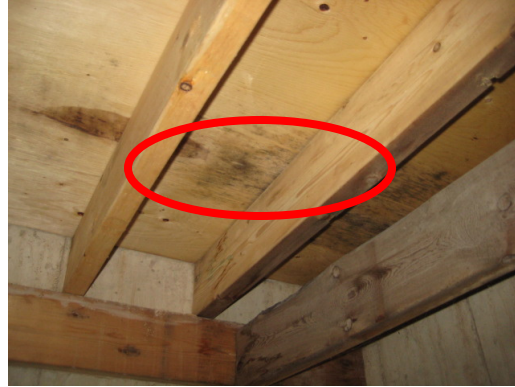
Black discoloration noted at ceiling which may be mould. Recommend increasing ventilation to the room. See Environmental Section for further information.
